## Expert Process Support Extends Membrane Life And Reduces Membrane-Related Expenditures By 65%

### Company Profile

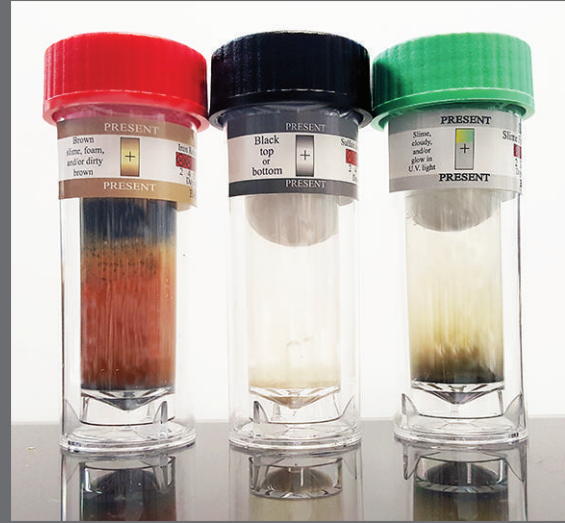
Day 5 BART showing a positive result for iron-related (left) and slime-forming (right) bacteria.

A King Lee application specialist visited the site for a support consultation. Investigation confirmed the root cause was from the presence of bacteria in the source well. Recommendations were made, including well disinfection, which helped extend membrane life and reduced overall membrane-related expenditures.

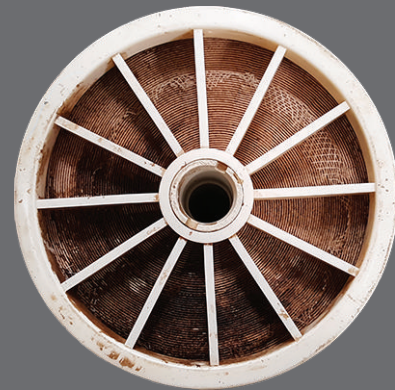
Well water feeds the RO system, which had been experiencing increases in differential pressure, suggesting the membranes were scaling and/or fouling. Scaling typically happens in the tail end of a system, while fouling typically occurs at the front end. The operational data did not clearly identify the cause. Pretreat Plus® Y2K, a robust broad-spectrum antiscalant, has historically been injected ahead of the cartridge filters and, when dosed properly, should have mitigated any scaling potential. Typically, successful membrane cleaning can help narrow down what is collecting on the membrane surface, leading to prevention. However, specialty membrane cleaners were used without much success because of the severity of the fouling, thus requiring membrane replacement yearly.

Pre-autopsied membrane element showing severe fouling.
